# Seismic Structural Failure Potentialities of Newly Constructed Buildings in Iran

**ABSTRACT:** As Iran is located at high seismic risk region and future ground motions are predicated by seismologist, thus, A Case study was conducted to investigate the major seismic structural failure potentialities due to design and constructional flaws in two province of Iran, Tehran and Esfahan, the former with high seismic risk and the latter with an intermediate risk. More than forty buildings were inspected to find the four major failure potentialities in these two provinces. Two imperfections were found in steel structures and two in reinforced concrete buildings. Design and constructional imperfections in protected zone in steel structures and latticed column details are two main points threaten newly constructed steel structures. In reinforced concrete structures, stairway constructional flaws and wrong pipe passing constructional details are the two main defects covered in this study for this type of structures. This paper also presents solutions for each failure potentiality and recommends some constructional and design hints to increase the safety of structure and make them ready for

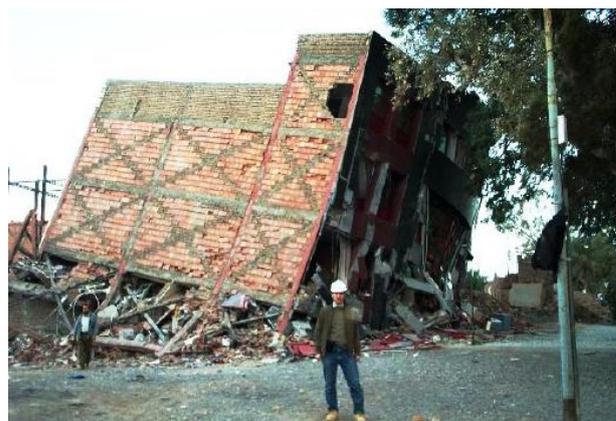
In December of 2003, Bam, a city located 1000 kilometres southeast of Tehran, faced with an earthquake with magnitude of 6.6 (Mw). 31,000 people killed, 30,000 injured and 75,600 people became homeless during this earthquake (USGS, 2003). Bam earthquake proved that constructional imperfection could lead to historical disaster. Poor welding design flaws and constructional imperfections were reported as three main reasons of Bam earthquake seismic failures. For instance, structural irregularities and poor welding were two factors which were responsible for the steel structure building in Figure 1.

Figure 1. Steel structure failure in Bam (Manafpour, 2008)

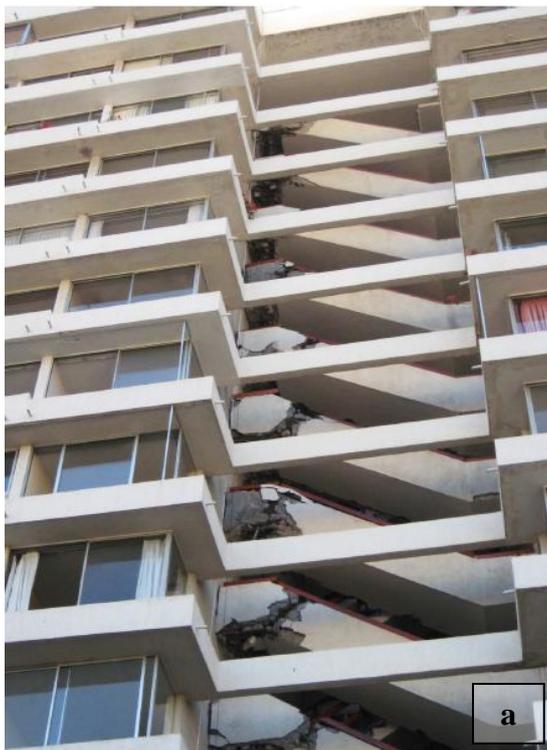
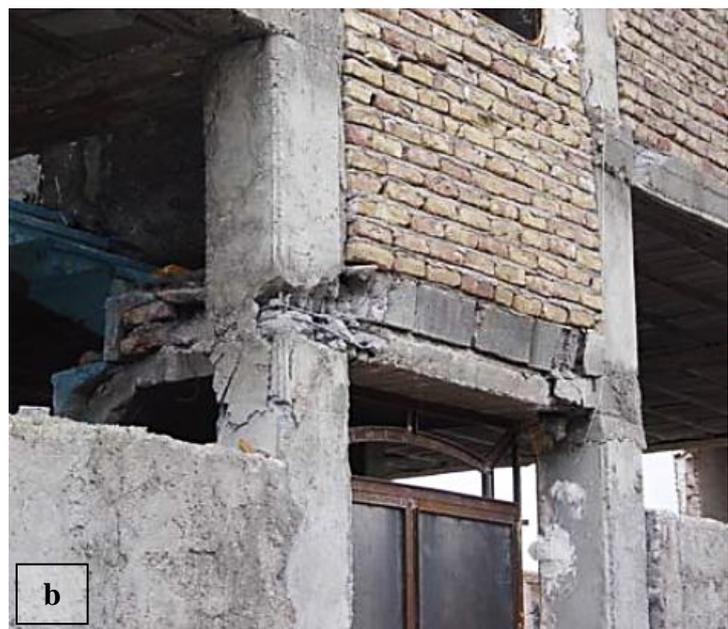
Therefore, there are two main failures possibility which may occur due to stairway-frame interaction defects. The first occurs where the main frame columns are stiff enough to handle the short column shear forces. Thus, in this case bracing action of stairway could fail the stairway fragile members (Figure 8a). The second risk about the interaction refers to column shear failure because of short column action and insufficient confinement of RC columns (Figure 8b).

**Figure 8.** Stairway-Frame interaction failure in past earthquakes; (a) 2010 Chile Earthquake stairway bracing action failure (FEMA E-74, 2011), (b) 2003 Bam Earthquake stairway short column failure (Vaseghi, 2003).

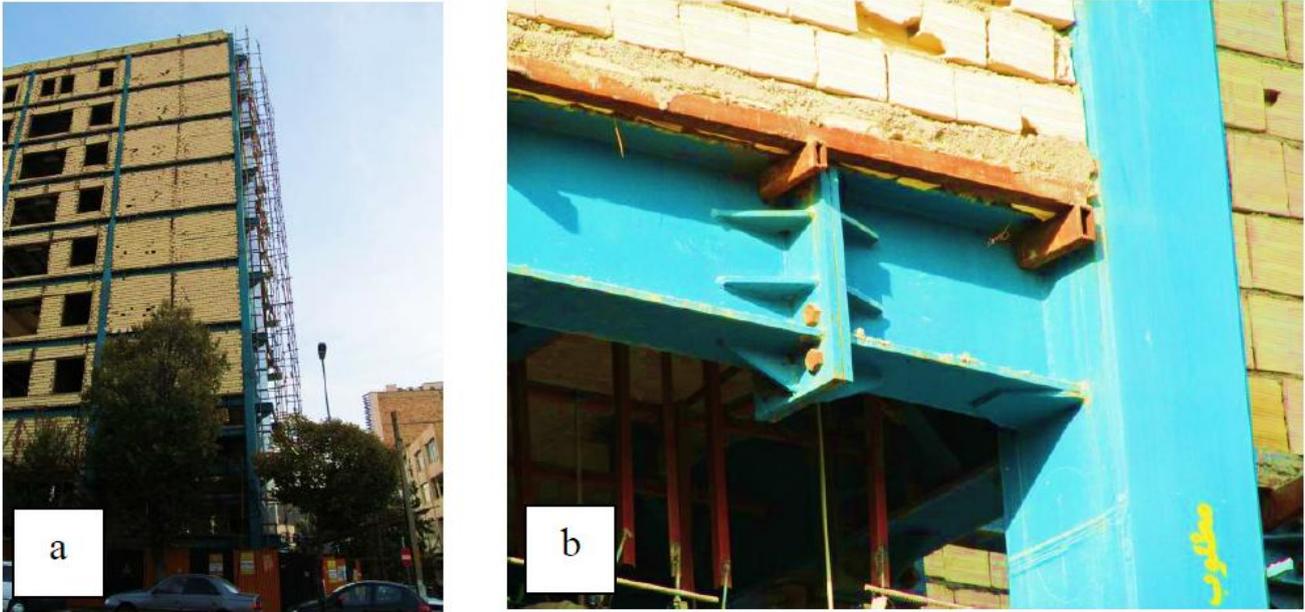
Figure 9a shows a steel moment frame structure with ten stories above ground level. This building is located in Tehran and the photo has taken in 2013. Figure 9b clearly illustrates that the exterior wall erection aid has been welded to the beam and the protected zone requirements have not been considered in this structure. As engineers expect inelastic behaviour of steel structures in high risk zone, such as Tehran, these types of constructional incorrect details could lead to a rapid fracture in protected zone and energy dissipation will stop in first cycles of seismic loading.

**Figure 9.** Ten-story Steel structural with protected zone imperfection; (a) building elevation, (b) beam-column view

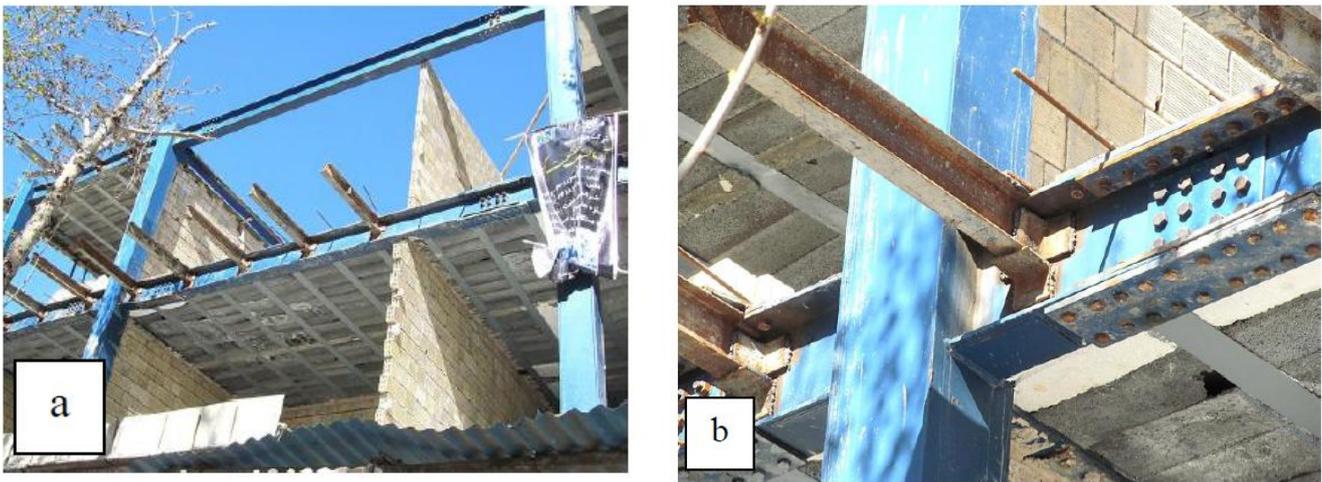
It is apparent from Figure 10 that the same defects threaten structures in Esfahan province, too. Design engineer restrained cantilever beam with high end bending moments to zone which expected to behave in elastically during ground motions. Thus, the early fracture at beam end web plate is expected to happen in future earthquakes. Note that beam splice could make failure condition worse in these three-stories building in Esfahan.

**Figure 10.** Three-story Steel structural with protected zone imperfection; (a) building elevation, (b) beam-column view

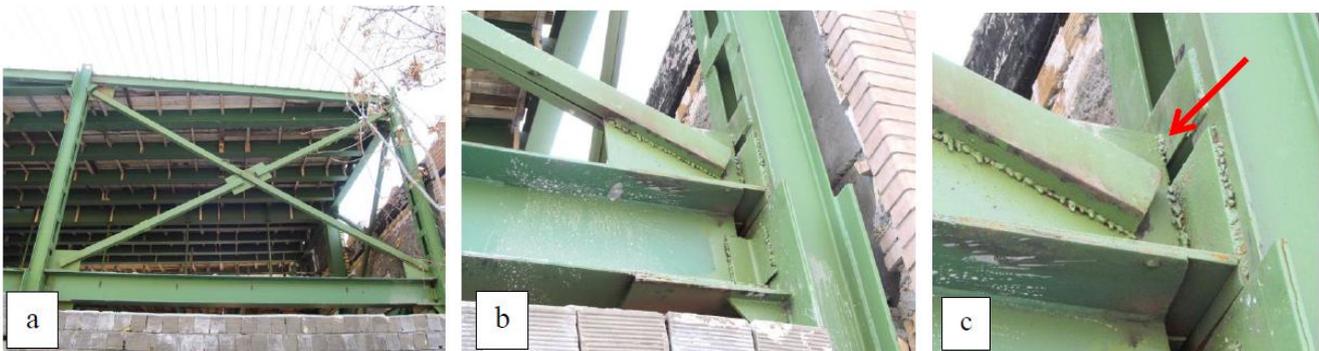
As indicated in Figure 11a, a two-story building in Esfahan has constructed in 2013. The Figure 11b shows that the gusset plate interrupts the lacing and based on AISC 360, an intermediate tie plate is required. There are two main constructional imperfections in this specific case study. The first refers to the length of intermediate tie plate along the length of column. As it is shown, the constructor used two different sizes of intermediate plate (Figure 11b) and the length of the plates is not sufficient for gusset plate-column connection. The second significant defect is the incorrect connection between the gusset plate and lacing plate. Theoretically, lacing plates are design to resist a large shear forces between two components of built-up column, not for flexural forces. Figure 11c clearly shows that the bracing member would apply tensile or compressive load to the gusset plate as a result of lateral displacement of frame. Then the gusset plate transfer this load to middle part of lacing plate (via welded connection) and force this small shearing-resistance element to resist large flexural force.

**Figure 11.** Two-story Steel structural with tie plate imperfection; (a) building elevation, (b) beam-column view, (c) detail view of connection

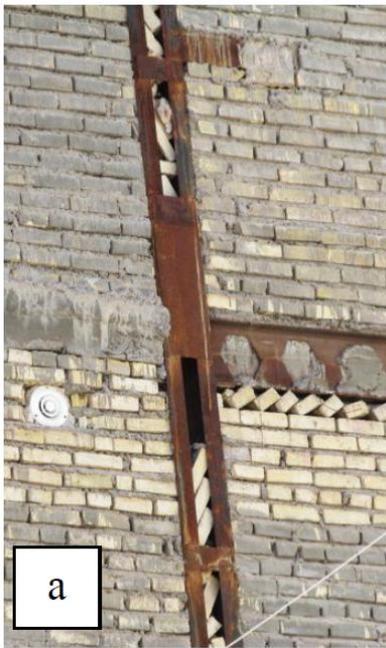
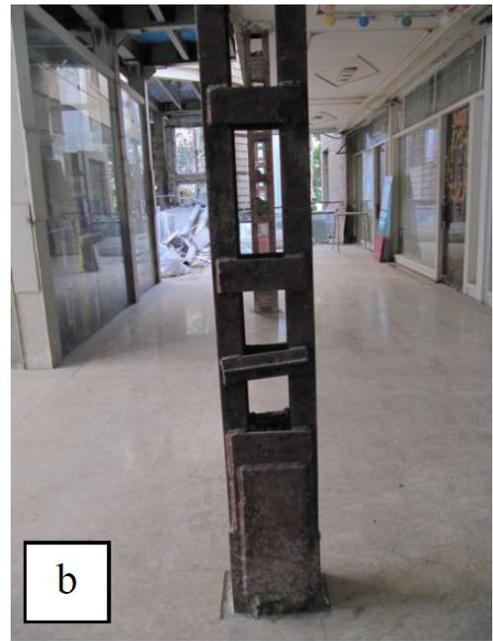
Figure 12a and 12b are two other constructional details with incorrect use of intermediate tie plate and inappropriate lacing arrangement, irregular lacing plate spaces in Esfahan, respectively. All of these details could cause unpredictable deflection and irregular stress distribution between two components of built-up column.

**Figure 12.** Two buildings with constructional defects; (a) Incorrect usages of tie plates, (b) irregular arrangement of lacing plates

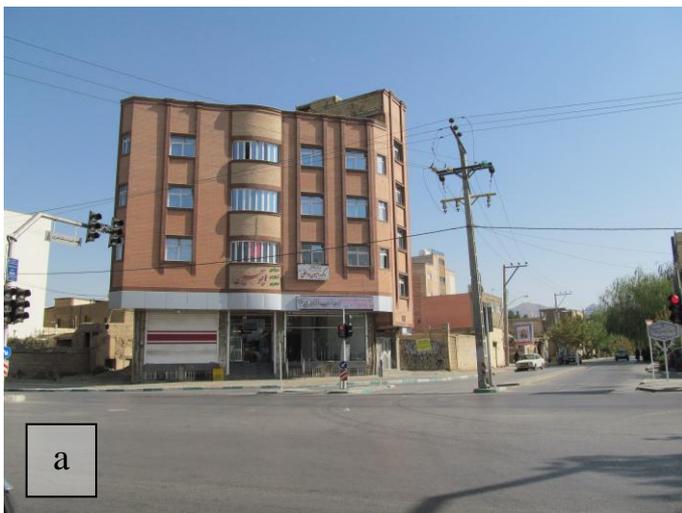
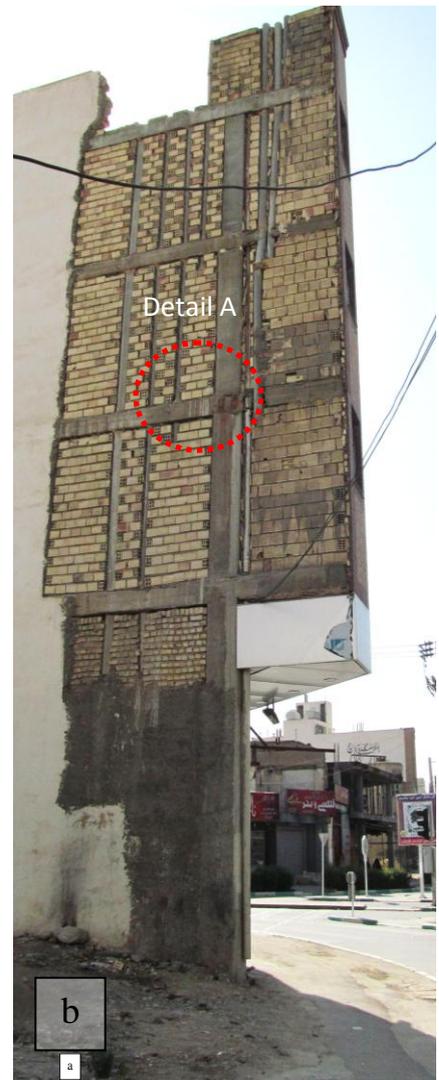
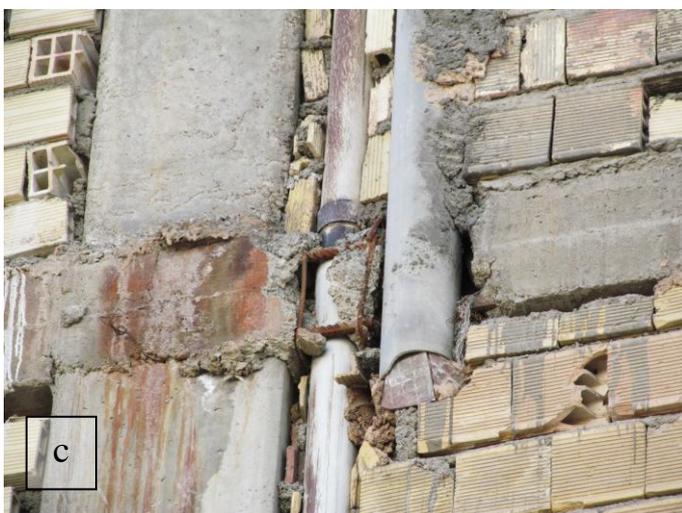
An intermediate reinforced concrete moment frame is shown in Figure 13a this building has four stories above ground level and one story beneath it. The east elevation of this newly built structure is shown in Figure 13b. The cantilevered RC beam with sleeve passing is also existed. The cantilever beams are the most sensitive member of moment frames which can absorb enormous vertical seismic load and show an enormous upward-downward deflections during earthquakes. Theoretically, cantilevers should resist a large flexural moment at their fully restrained ends. Based on the 2011 ACI 318, sleeve passing shall not reduce the strength of the member significantly. Thus, passing three sleeves through the region close to the high bending stress zone in this building is structurally incorrect and could increase the failure risk of this building even in lower seismic excitations (Figure 13).

On the basis of the precise structural inspection of the beam-column joint and sleeve passing constructional detail, it is observed that top and bottom longitudinal reinforcements in second floor cantilever beam of this building have been cut because of non-existence of mechanical detail drawings (Figure 13c). This structure is so brittle. Therefore, the cantilever beams end connections prone to fail in first cycles of seismic load application. This fact should be considered that horizontal structural irregularity of this building could increase the failure risk of this building, too.

**Figure 13.** Wrong pipe and sleeve passing through cantilever beam; (a) Building North elevation, (b) Building East elevation, (c) detail A- Beam to column connection detail

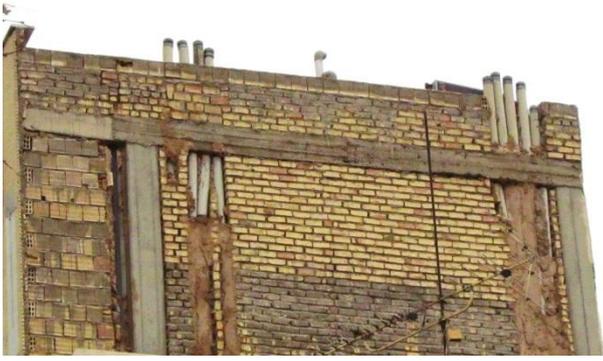
The top beam of three-story RC intermediate moment frame building is shown in Figure 14. The number of sleeves and spaces between them are incorrect, based on ACI 318 requirements, at left and right ends of the beam. The high bending moments are expected to occur at two ends of structural frame beam. Thus, passing mechanical sleeves through this location could impair the strength of beam significantly and could put this building at high risk of failure in future ground motions.

**Figure 14.** Wrong pipe and sleeve passing through high bending moment zones

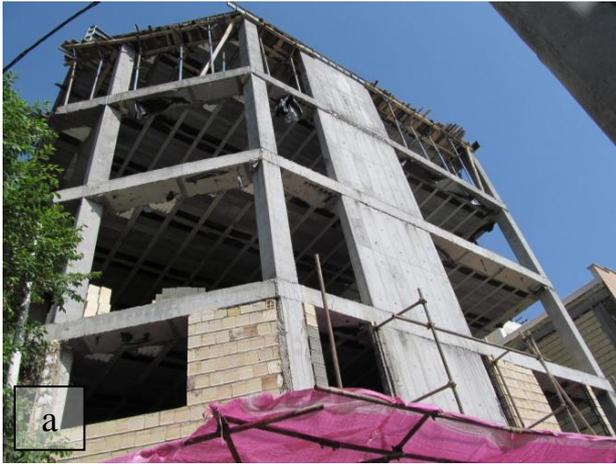
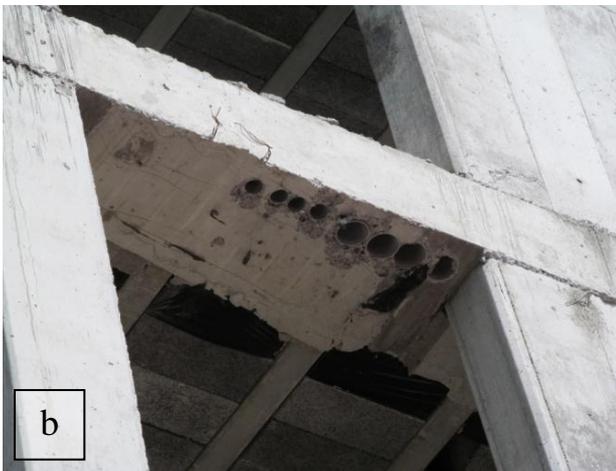
A five-story building with a dual system (moment frame plus RC shear wall) is the next case. This building is located in Esfahan and under construction. There are eight pipe vacant spaces in beam next to shear wall. These holes are placed next to each other. About two-thirds of beam length contains holes for pipe and sleeve passing which could greatly reduce the total strength of this member (Figure 15). Passing pipes and sleeves close to structural joints are incorrect due to high bending and shear forces existence in these zones.

**Figure 15.** Five-story building with unacceptable pipe passing detail; (a) overall view, (b) beam-shear wall connection detail

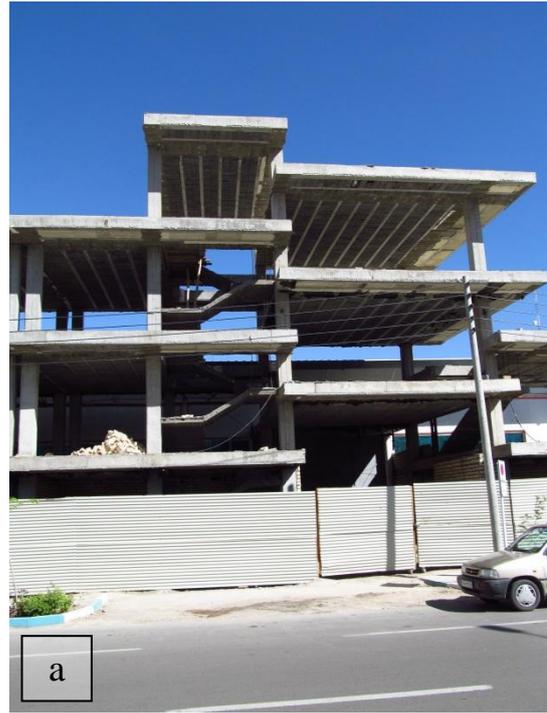
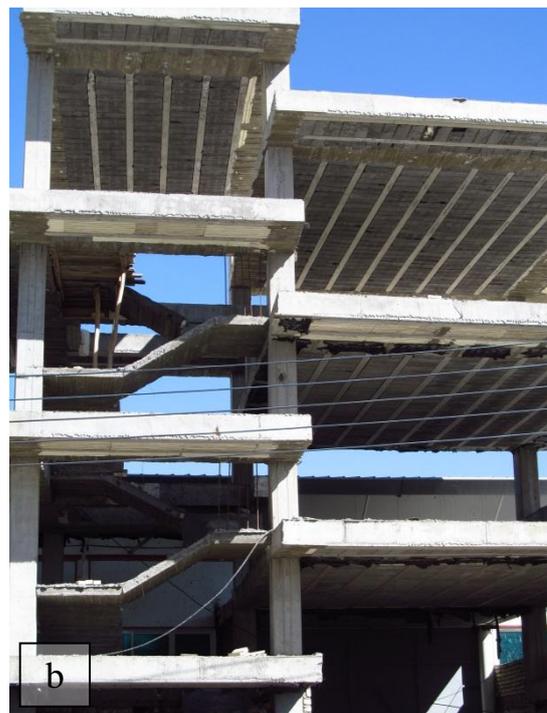
Failure is one of the most critical issues which threaten the safety of buildings in these two particular cities. The first failure potentiality is stairway failure due to bracing action. As it is shown in Figure 16, the connections of stairway to main frame are fixed and brace action of stairway under lateral seismic forces is predicted. In addition, because of fixed-end connection of stairway, the C1 column is at high risk of brittle shear failure due to short column occurrence. It has to be mentioned that because of mid-height floor slab existence, the column C2 is at very high risk of failure under severe short column action between two adjacent

floor slabs. This could increase the risk of stairway bracing action failure and column C2 shear failure, too. The two other buildings in Figure 17a, and 17b show the failure potentialities in Iran, particularly Esfahan and Tehran. In both buildings, fixed-end stairway connections to building frame put these structures in high risk of failure.

**Figure 16.** Stairway-Frame interaction failure potentialities; (a) building view, (b) detail view

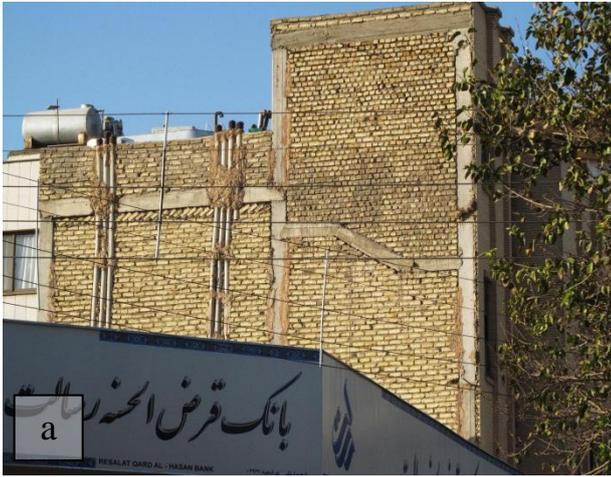
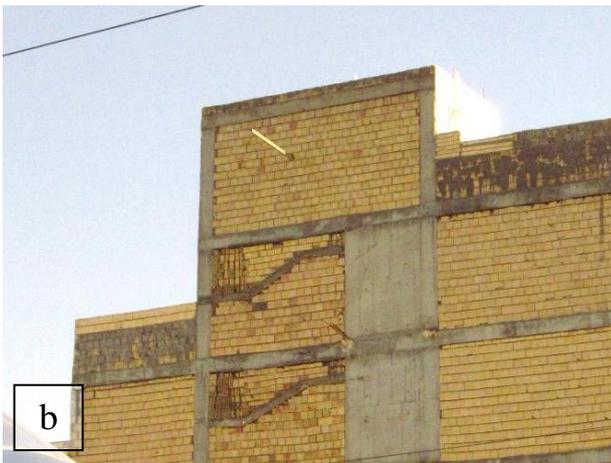
**Figure 17.** Two buildings in Esfahan with high risk of brittle stairway and short column failure
