# Condition Assessment of Metsimotlahe River Bridge using Non-Destructive Testing and Non-Contact Procedure

A process of in-service infrastructure health assessment using non-destructive testing and evaluation (NDT&E) techniques is crucial for prompt, accurate and quantitative identification of damage in civil infrastructure. The aim of this study was to assess the structural performance of Metsimotlahe River Bridge through NDT&E and load testing techniques. Schmidt rebound hammer was utilized to determine the compressive strength of the bridge, total station was used to monitor the profile of the bridge girder level for differential deformation, and a non-contact global positioning system (GPS) technology was employed to measure the dynamic displacement of the bridge under random operational traffic loading conditions. Finally, the dynamic behavior of the bridge was evaluated based on displacement, strain and acceleration response data. There was a perfect linear correlation between rebound number and compressive strength of concrete from different contact surfaces. The compressive strength of the bridge superstructure from random sampling was 39.48 N/mm<sup>2</sup> (CoV = 19.22%

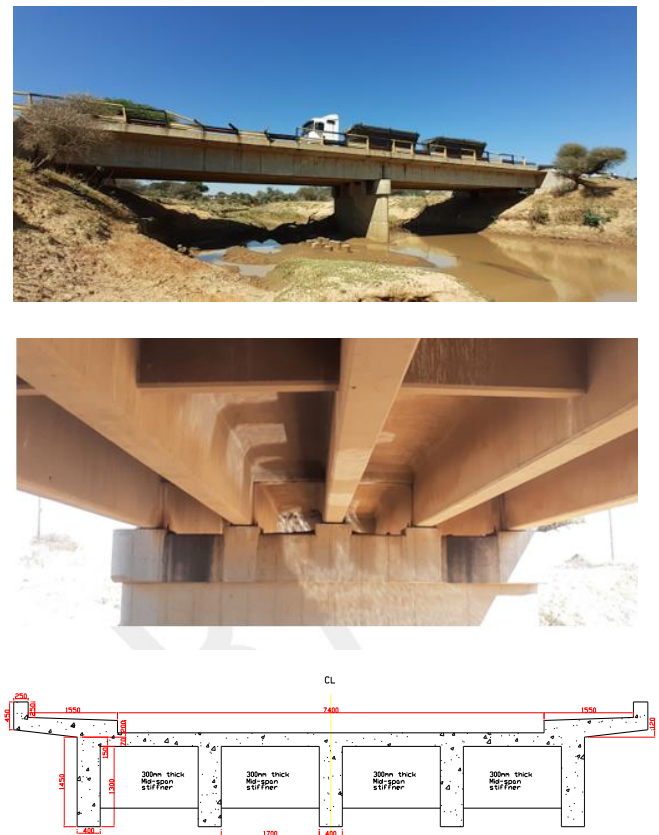
**Figure 1.** The elevation, the underside view and cross-section of Metsimothlabe Bridge

The bridge consists of two spans simply supported RC beam and slab supported on a wall type solid pier. The total span is 42.6 m and total width is 12.1 m. There are 1.5 m wide walkways on either side of the roadway with steel railing parapet. Each span length is 21.3 m comprising five girders spaced at 2.1 m centers. The width and overall depth of the girders are 400 mm and 1500 mm respectively. There are two wall type abutments and RC wall pier. Deck construction method is cast in-situ on stationary false work and the bearing type is elastomeric, teflon and stainless-steel plates. The vertical alignment of the bridge is at a constant gradient of 0 to 2%, horizontal alignment is straight, camber/cross fall is 2 to 4%, and the angle of skewness is zero degree. Minimum vertical clearance is 6.5 m and the bridge altitude is at 900 m above mean sea level. The surface on deck and approaches is asphalt. Figure 1 illustrates the bridge elevation, underside and profile section.

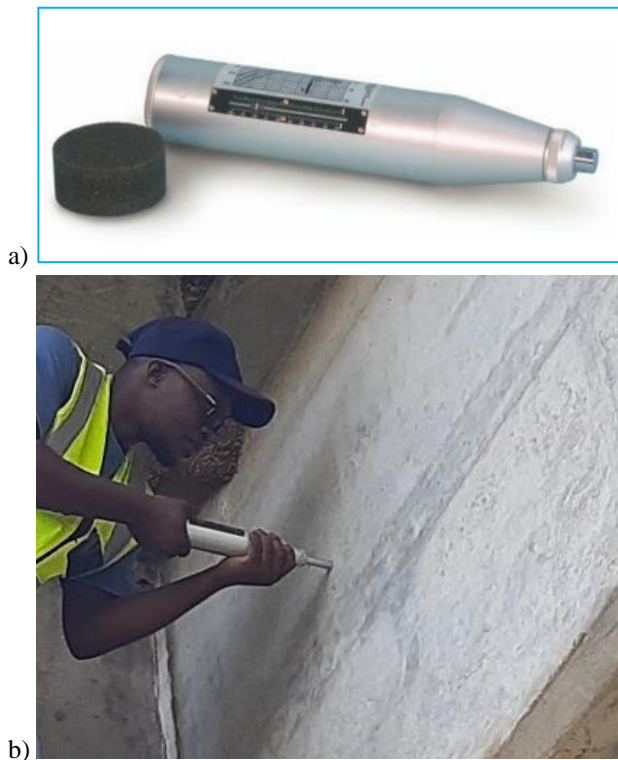
**Figure 2.** (a) N Type concrete test hammer and (b) on-site test process

The effectiveness of Schmidt hammer in determining concrete compressive strength of the bridge superstructure was implemented in accordance with EN 13791 (2007) and EN 12504-2 (2012). The impulse test hammer (rebound hammer) is a simple, quick and inexpensive to use and was calibrated with a total of 36 precast concrete cubes of different predetermined compressive strengths between 20 and 35 N/mm<sup>2</sup>. The N Type MH-75 model Concrete Test Hammer (Schmidt Hammer) was used as shown in Figure 2 together with the on-site test process. Prior to field test, the rebound hammer was calibrated to establish the relationship between compressive strength and rebound number.

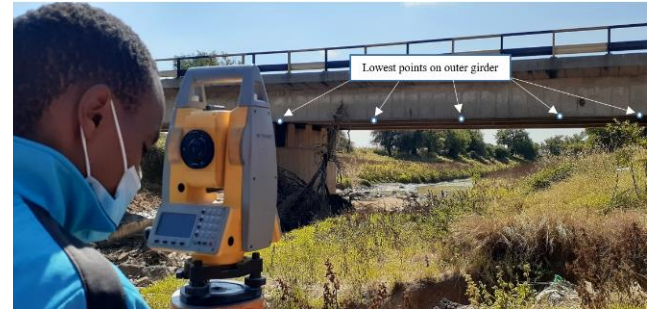
**Figure 3.** Bridge data collection using the Hi-Target total station

A Hi-target ZTS-420R total station with absolute encoding measurement method was used on Metsimotlhabe River Bridge to determine the bridge elevation in order to quantify the permanent vertical displacement measurements of the deck. For on-site

deformation monitoring, 10 monitoring points, A1 to A5 and B1 to B5, spaced at 5.325 m at the northern and southern sides respectively were marked on the external bridge girders as shown in Figure 3. Two control points were also established and fixed on stable ground on either side and away from the bridge. Three observations of data for each monitoring point were undertaken to minimize measurement errors.

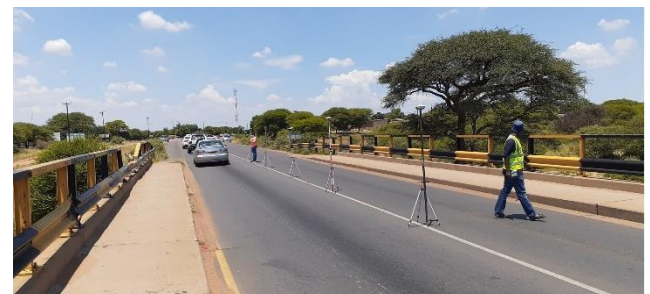
**Figure 4.** Field data capturing using GPS receivers

Real-time kinematic (RTK) dynamic displacement data of the bridge girder under random traffic loading was monitored using GPS survey equipment at a sampling rate of 10 Hz. Five rover observation stations were each considered along the center-line of the bridge as depicted in Figure 4. Each rover station was observed for about 15 minutes for each cycle. On the observing point, the GPS antenna was placed vertically on the bridge surface, which reflects the movement of the bridge completely. Three sets of data were collected and pre-processed using GPS-Trimble software in the analysis. The output of the GPS software was the time series of the instantaneous Cartesian coordinates of the rover receiver in the World Geodetic System (WGS84) coordinate system.

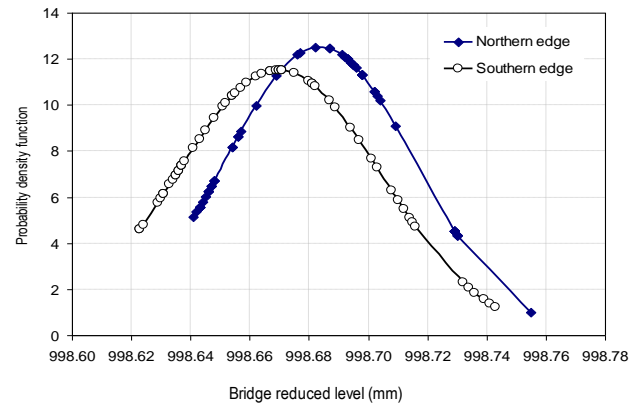
**Figure 6.** Normal distribution graph for north and south edges data.

The reliability of the data of the bridge profile was ascertained by a set of random data analyzed to determine its variability where the traditional statistical functions, mean, standard deviation and coefficient of variation were estimated. In addition, as shown in Figure 6, the results show that the north and south profile data is normally distributed. The bridge levels data depict similar results.
