# Evaluation of Stability of Spillway Gable Roof of Nazlu Dam via Slide Software

**ABSTRACT:** The most prominent issue in the civil projects such as construction of dams is providing stable steep slopes of rocks and stones. Such studies aim at providing a gable roof's stability coefficient in order to provide stability as well as an economical solution. This survey will analyze the gable roof's stability overlooking to the overflow body of Nazlu dam. According to results of exploratory boreholes related to the bed and results of investigation of particles existing on the gable roof, it can be deduced that crunch levels of gable roof's stones, their oxidation, continuation rate (the extent or duration of discontinuities), level spacing (the amount of vertical spacing between adjacent discontinuities of a joint sets), and patency rate (amount of vertical spacing between adjacent walls of a discontinuity) is variable between minor to moderate cases, minor to moderate cases, 1 to 10 mm, 0.2 to 1, 2 to 10 mm, respectively. Filling-in rate of the stones is made of CaCO<sub>3</sub> and sometimes calcic or clay. The shale part of the gable roof is severely crunched which indicates its in

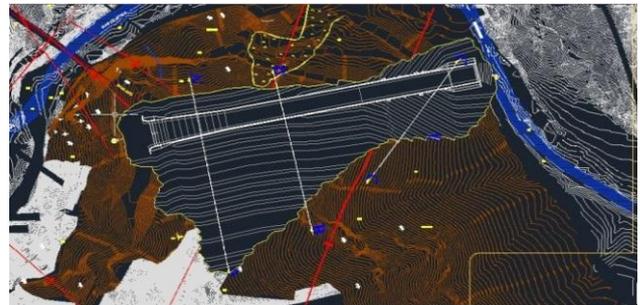
Figure 1. A View of the spillway of Nazlou dam

Nazlu dam is located on the Nazlu River in the northwest region of Iran named West Azarbaijan and its distance to Urmia city is about 28 km. This dam is near mountains between the desert of the west Urmia Lake and hillside of the eastern region of the border between Iran and Turkey, called Targavar. The location of the dam has following geographical coordinates: latitude coordinates are 37 degrees and minutes to 38 degrees and east length coordinates are 44 degrees and 30 minutes to 45 degrees and 15 minutes. The main materials used in construction of Nazlu dam or gravelly soil with vertical clay core, and its height from the bed of the river is about 98.5 m, the length and width of dam crest is respectively about 420 m and 12 m. The width of the base is 480 m and the total capacity of the reservoir is 170 million m<sup>3</sup>, which is able to hold about 230 million m<sup>3</sup> within itself. Figure 1 represents a view of overflow section.

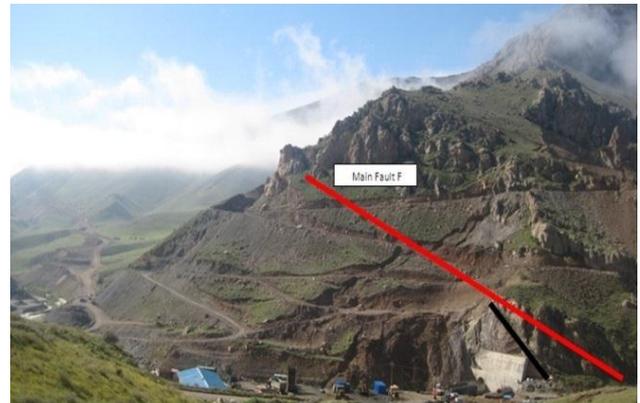
Figure 2. A view of fault f from outlet of tunnel

Beside that we investigated the structure of stones, we also put effort in surveying the kinds and treats of discontinuities existed in the stones of a gable roof and the results implied that these discontinuities along with the various orientations and directions have affected the right abutment. These discontinuities are mostly free from any displacements and crunches and among these discontinuities only fault f possesses displacement. This fault has placed calcareous masses on the sale section, so we observed crunches and displacements most in the shoot part of the spillway. Consider Figure 2 as a view of fault from the outlet of the tunnel.

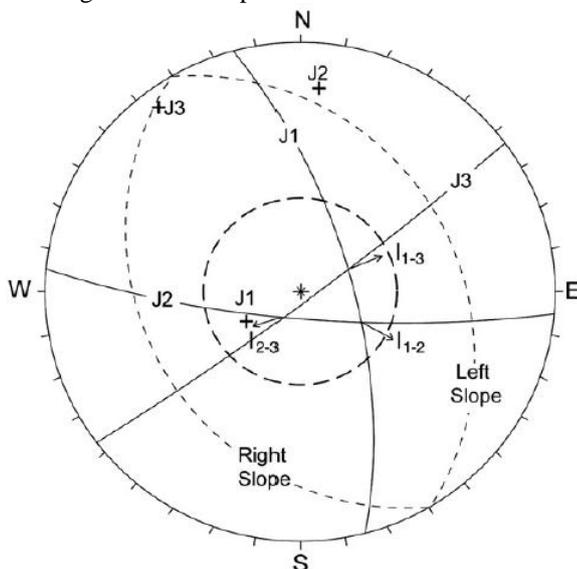
**Figure 4.** Kinematical analysis of the right and left slopes

Assessment of slope stability in rocks is usually done through kinematical analyses, limit equilibrium analyses and numerical methods such as finite element method. If the kinematical analysis indicates that the failure controlled by discontinuities is likely, the stability must be evaluated by a limit equilibrium analysis, which considers the shear strength along the failure surface, the effects of pore water pressure and the influence of external forces such as reinforcing elements or seismic accelerations (Turner and Schuster, 1996). Additionally, the results appeared form kinematical and limit equilibrium analyses are performed using numerical methods to confirm if slope is stable. In this study, the kinematical analysis and finite element method are done for the right and left slopes which will cut at the dam site.

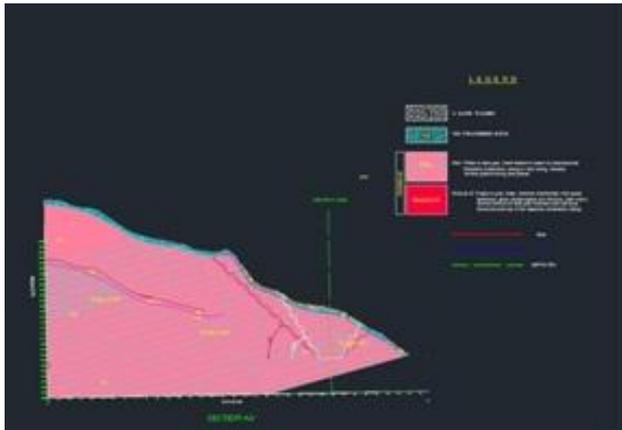
**Figure 5-** The cross-sectional plane AA'

According to prepared maps, the initial lengths to the median section of the spillway and the initial section of spillway shooting part (cross sectional AA' and BB') are made of calcic-stone mass and calcic-dolomite. As we

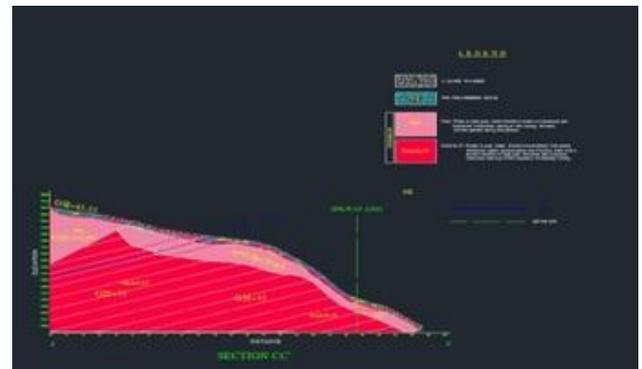
**Figure 7.** The cross-sectional plane CC'

approach toward the end of the spillway section (mostly situated on CC') the shale stones increases, when it is compared with calcic. As the cross sections 'BB and CC' display, because of Fault F, the calcic stones are located on shale layers. With regard to the structural conditions of rock mass involving parapets, instability potential of cross sections like AA', BB' and CC' according to investigation shapes and possible instabilities are identified. So, by considering measurements and geometry treats of steep and strength parameters, the discontinuities levels and rock mass, the analysis of stability was done by Slide software. It should be pointed out that, the stability analysis is done in static and quasi-static states. According to seismicity report, the numeral value of horizontal acceleration was equal to 0.3 g (equal to level of seismic design). It is worth stating that security factor in static analysis and quasi-static analysis was based on Din 1054, 1.5 and Din 4084, 1.1 Standard, respectively.

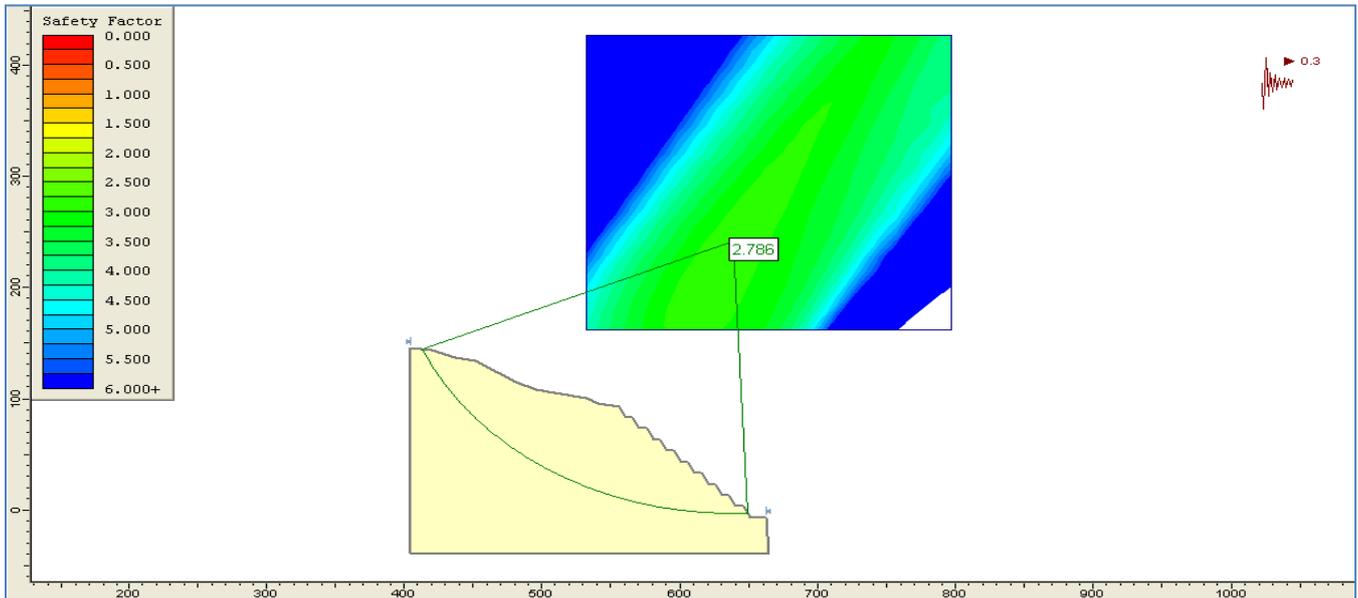
**Figure 8.** The results of quasi-static analysis on AA' cross section with parapet steep of 45 degrees

In this case the value of AA' and BB' for parapet steep were 45 and 60 degree and security factors in static and quasi-static states for the AA' and BB' cross sections are presented in table 8 which it can be deduced that the sum of the exerted forces was constant. But, in quasi-static case, the force that is due to Horizontal acceleration of earthquake cannot be ignored. The average of confidence in a static state in AA' is equal to 4.39 and in quasi-static state is equal to 2.77. This parameter on BB' crosses section in static and quasi-static states are equal to 2.96 and 2.82, respectively.

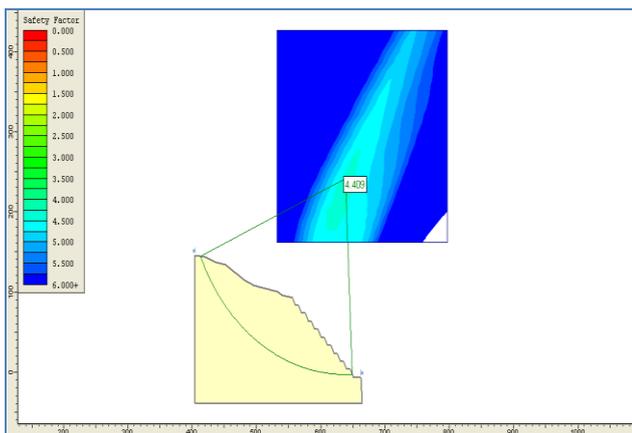
**Figure 9-** The results of static analysis on AA' cross section with parapet steep of 45 degrees

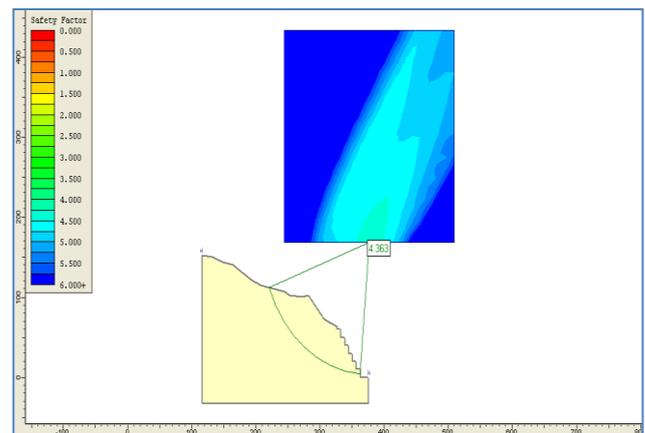
**Figure 11-** The results of static analysis on AA' cross section with parapet steep of 60 degrees

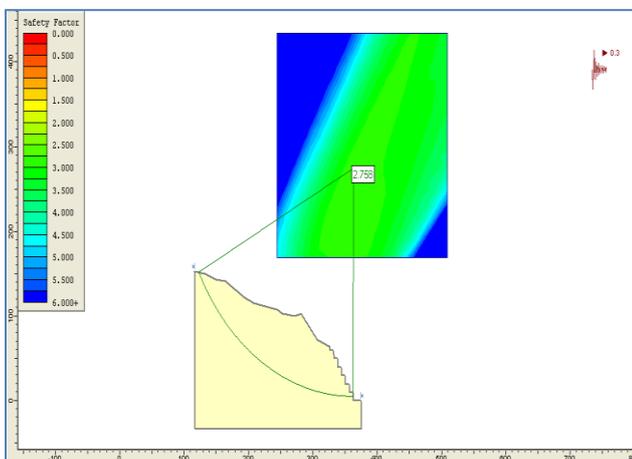
**Figure 10-** The results of quasi-static analysis on AA' cross section with parapet steep of 60 degrees

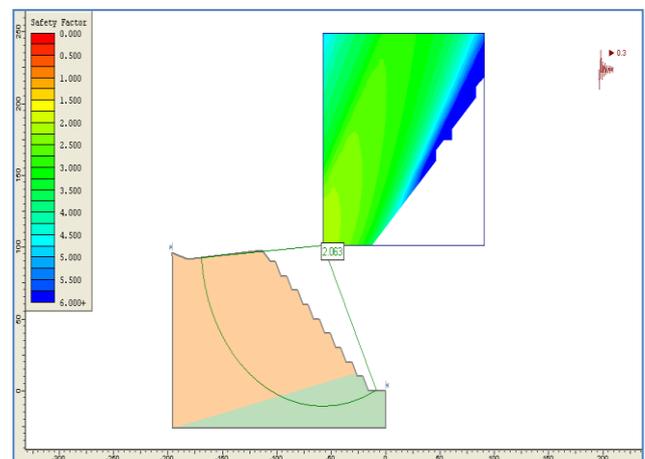
**Figure 12-** The results of quasi-static analysis on BB' cross section with parapet steep of 45 degrees

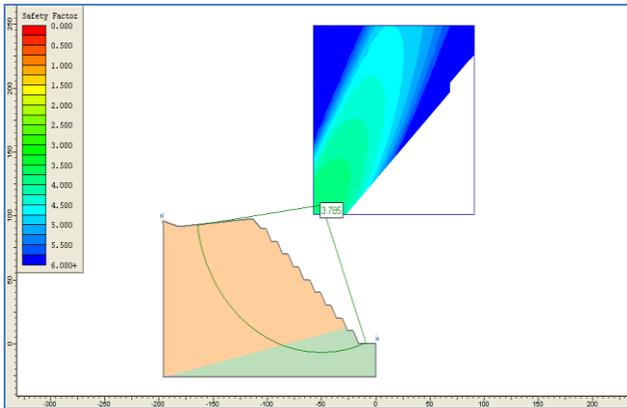
**Figure 13-** The results of static analysis on BB' cross section with parapet steep of 45 degrees

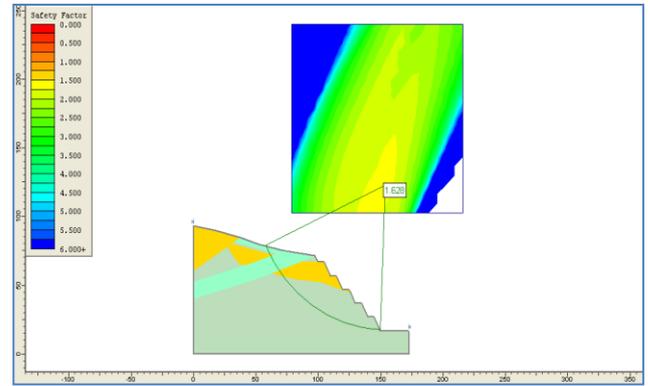
**Figure 17-** The results of static analysis on CC' cross section with parapet steep of 45 degrees

On CC' cross section the steep of parapet is equal to 45 and 40 degrees, the security factor in static and quasi-static cases for CC' cross section is presented in Table 9. The average of the security coefficient in static and quasi-static cases at CC' approximately is equal to 1.65 and 1.02, respectively.

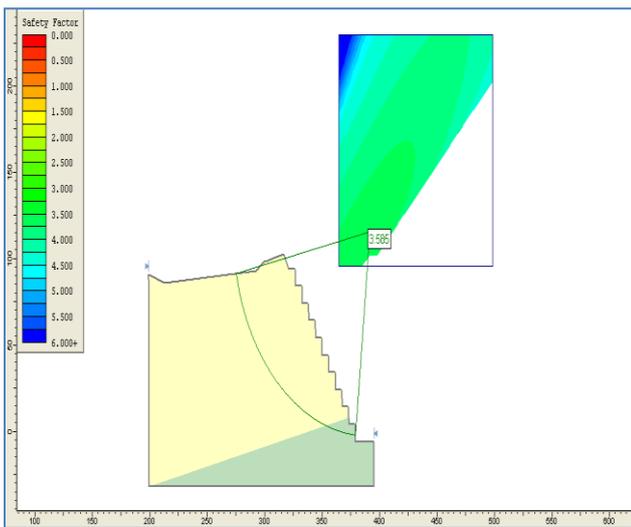
**Figure 14-** The results of static analysis on BB' cross section with parapet steep of 60 degrees

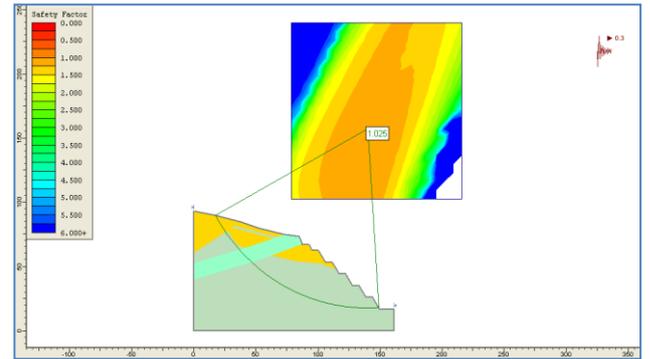
**Figure 18-** The results of quasi-static analysis on CC' cross section with parapet steep of 40 degrees

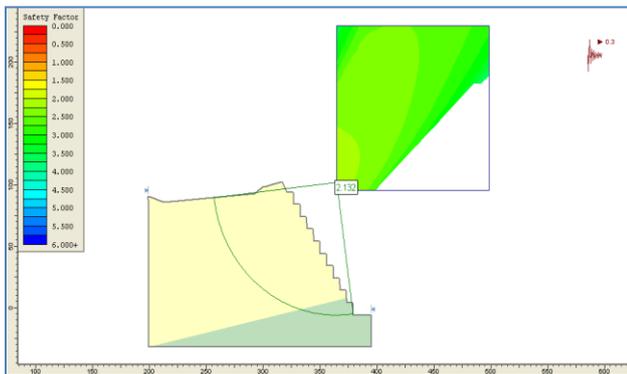
**Figure 15-** The results of quasi-static analysis on BB' cross section with parapet steep of 60 degrees

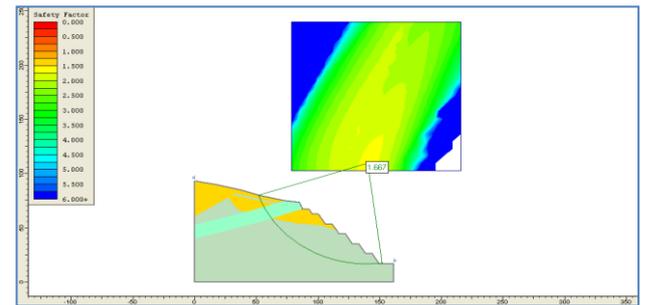
**Figure 19-** The results of static analysis on CC' cross section with parapet steep of 40 degrees

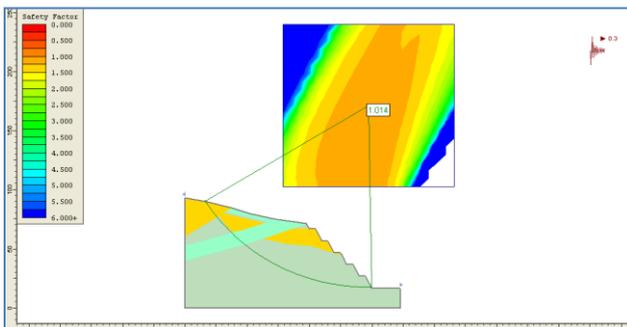
**Figure 16-** The results of quasi-static analysis on CC' cross section with parapet steep of 45 degrees
